Trouble Shooting help for SpotClean AutoMate @ SCA

SpotClean AutoMate 4720X

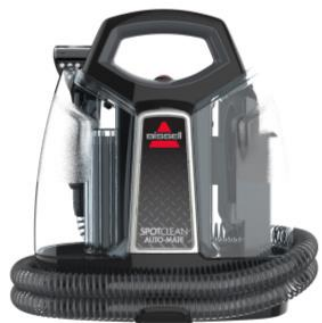
Problem	Causes	Remedies
Machine wont pick up fluid	Customer not holding tools at correct angle	Get customer to show you how they use the product.
	Dirty Water Tank is full.	Empty tank.
	Excess formula in Flex Hose.	Lift tool and point upwards to allow water in hose to flow into the Dirty Water Tank.
	Incorrect cleaning formula tank has excess foam in it	Use BISSELL® 2X Portable Machine formulas only.
	Dirty Water Tank is improperly seated onto base.	Remove tank and reseal onto unit.
	Dirty Water Tank plug is unplugged.	Push in tank plug until properly sealed.
